SUMMARY INSPECTION REPORT

Sample Park - Sample Park Outdoor Play Area

01 July 2015

Annual Outdoor Playgrounds

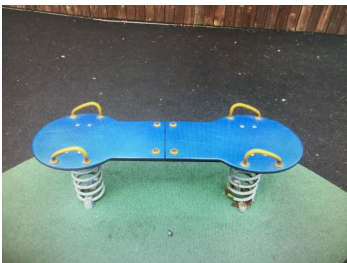
Equipment: Balance Beam Rocker

Equipment Type: Rockers
 Manufacturer: Ledon
 Installation Date:
 Compliant: Yes
 Inclusive: No
 Compliance: Outdoor
 BS EN 1176
 Surface: Unknown
 Priority: 1 / Quality: 10

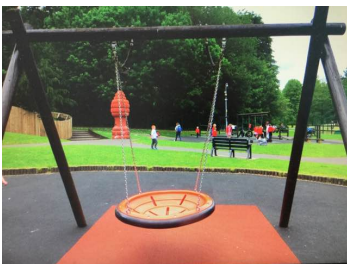
Equipment: Basket Swing

Equipment Type: Swings
 Manufacturer: Playdale Playgrounds Limited
 Installation Date:
 Compliant: Yes
 Inclusive: Yes
 Compliance: Outdoor
 BS EN 1176
 Surface: Unknown
 Priority: 1 / Quality: 10

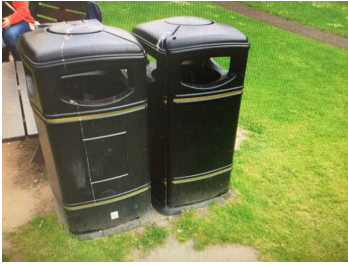
Equipment: Bin

Equipment Type: Ancillary Manufacturer: Not applicable Installation Date: Compliant: Yes Inclusive: No Compliance: NONE Surface: Unknown Priority: 1 / Quality: 10

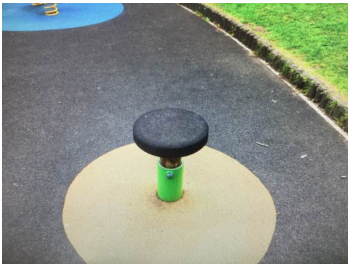
Equipment: Bouncing Disc

Equipment Type: General Manufacturer: Island Leisure Installation Date: Compliant: Yes Inclusive: No Compliance: Outdoor BS EN 1176 Surface: Unknown Priority: 1 / Quality: 10

Component: Base

Is the unit structurally sound

NO

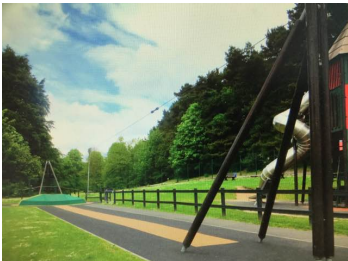
Equipment: Cableway

Equipment Type: Cableways Manufacturer: Playdale Playgrounds Limited Installation Date: Compliant: No Inclusive: No Compliance: Outdoor BS EN 1176 Surface: Unknown Priority: 8 / Quality: 3

Component: Spring stopper

Is the unit structurally sound

NO No Image

Is the item safe?

NO

P 7 Q 3	Broken stopper	Falls, cuts and bruises	Probability 3 × Severity 3 9	Replace stopper	Probability 1 × Severity 1 1	Regular routine inspections

Broken stopper	Replace stopper

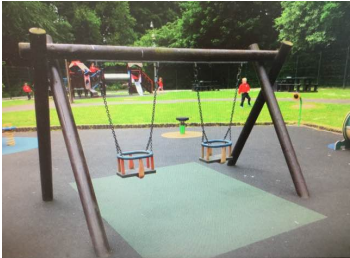
Equipment: Cradle Swings

Equipment Type: Swings Manufacturer: Playdale Playgrounds Limited Installation Date: Compliant: Yes Inclusive: Yes Compliance: Outdoor BS EN 1176 Surface: Unknown Priority: 1 / Quality: 10

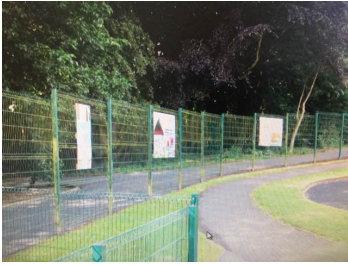
Equipment: Fencing

Equipment Type: Ancillary Manufacturer: NK Fencing Installation Date: Compliant: Yes Inclusive: No Compliance: NONE Surface: Unknown Priority: 1 / Quality: 10

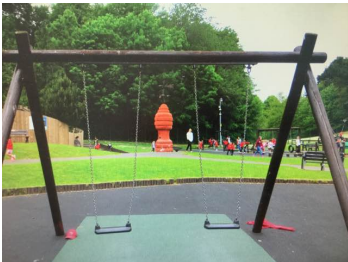
Equipment: Flat Swings

Equipment Type: Swings Manufacturer: Playdale Playgrounds Limited Installation Date: Compliant: Yes Inclusive: No Compliance: Outdoor BS EN 1176 Surface: Unknown Priority: 1 / Quality: 10

Component: Chains

Is it possible to replace damaged components prone to wear?

NO

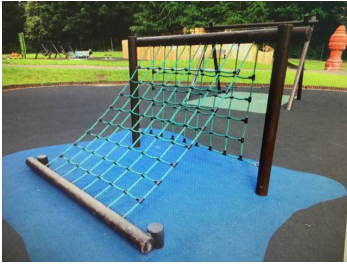
Equipment: Rope Climber

Equipment Type: General Manufacturer: Playdale Playgrounds Limited Installation Date: Compliant: Yes Inclusive: No Compliance: Outdoor BS EN 1176 Surface: Unknown Priority: 1 / Quality: 10

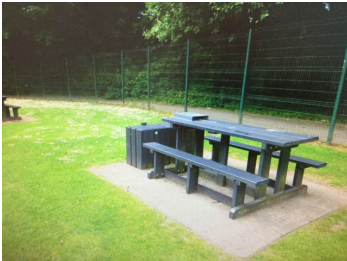
Equipment: Seats

Equipment Type: Ancillary Manufacturer: Playdale Playgrounds Limited Installation Date: Compliant: Yes Inclusive: Yes Compliance: NONE Surface: Unknown Priority: 1 / Quality: 10

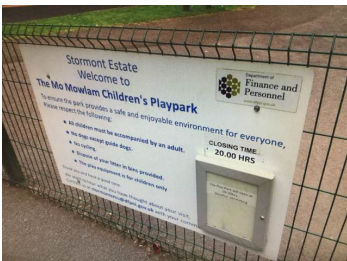
Equipment: Signage

Equipment Type: General Manufacturer: Not Available Installation Date: Compliant: Yes Inclusive: Yes Compliance: Outdoor BS EN 1176 Surface: Unknown Priority: 1 / Quality: 10

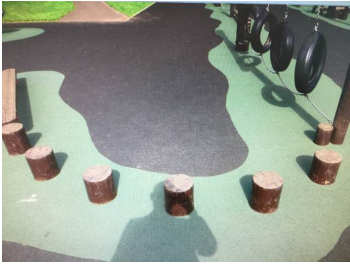
Equipment: Surfacing

Equipment Type: Surfacing Manufacturer: Garden Escapes Installation Date: Compliant: Yes Inclusive: Yes Compliance: Surfacing BS EN 1177 Surface: Unknown Priority: 1 / Quality: 10

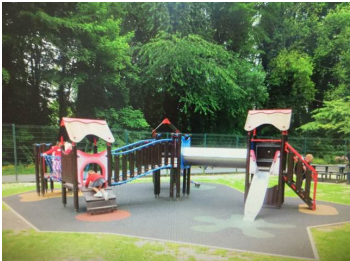
Equipment: Toddler Multi Unit

Equipment Type: General Manufacturer: Playdale Playgrounds Limited Installation Date: Compliant: Yes Inclusive: No Compliance: Outdoor BS EN 1176 Surface: Unknown Priority: 1 / Quality: 10

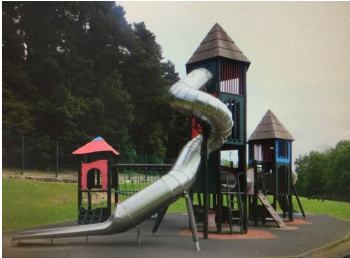
Equipment: Tower Multi Unit

Equipment Type: General Manufacturer: Playdale Playgrounds Limited Installation Date: Compliant: Yes Inclusive: No Compliance: Outdoor BS EN 1176 Surface: Unknown Priority: 1 / Quality: 10

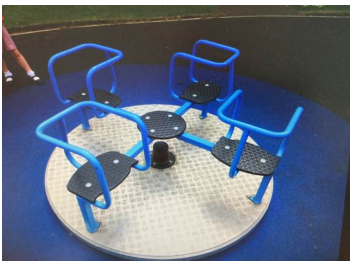
Equipment: Traditional Roundabout

Equipment Type: Carousels Manufacturer: Hags/SMP Limited Installation Date: Compliant: Yes Inclusive: Yes Compliance: Outdoor BS EN 1176 Surface: Unknown Priority: 1 / Quality: 10
